GEOTECHNICAL ASSESSMENT

Vermilion Airport Rehabilitation – Runway and Taxiway Vermilion, Alberta

**Town of Vermilion
c/o McElhanney**

Project File #: PG23-1717.R1

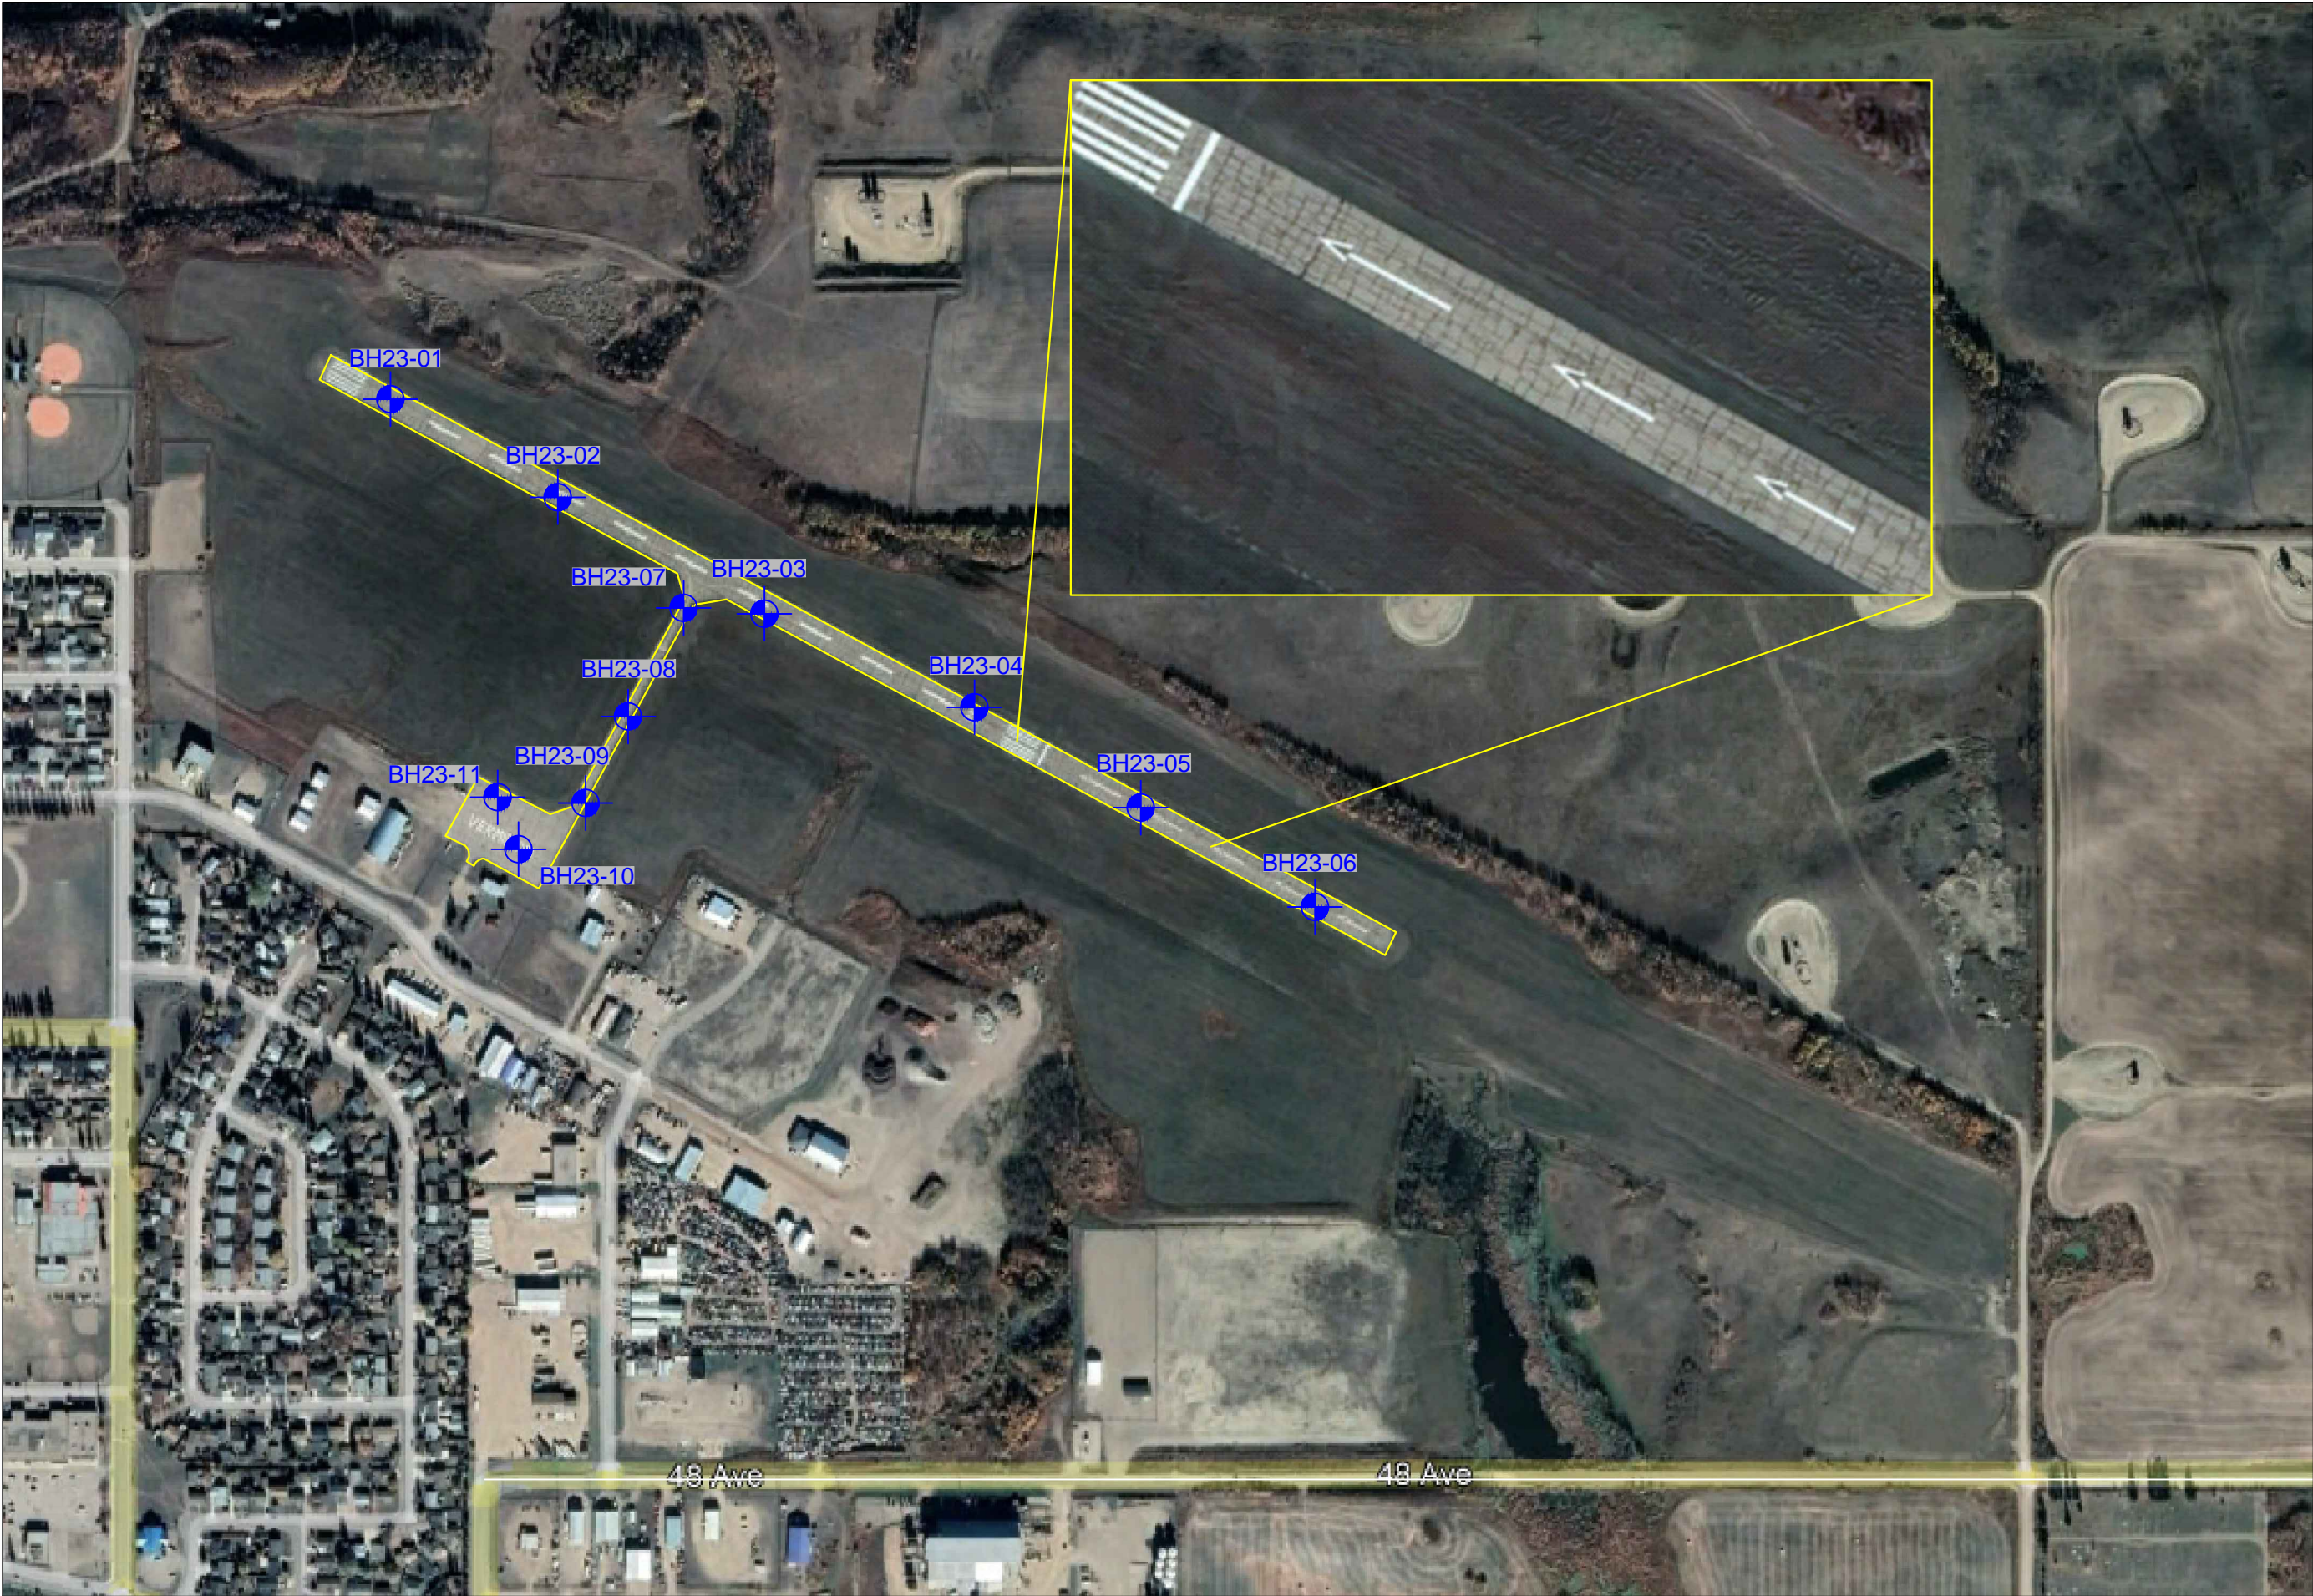
The borehole locations were selected and marked in the field by SolidEarth with consultation with McElhanney, with some of the boreholes being located within areas experiencing severe cracking. The borehole location plan on an aerial photograph is presented as Figure 1.

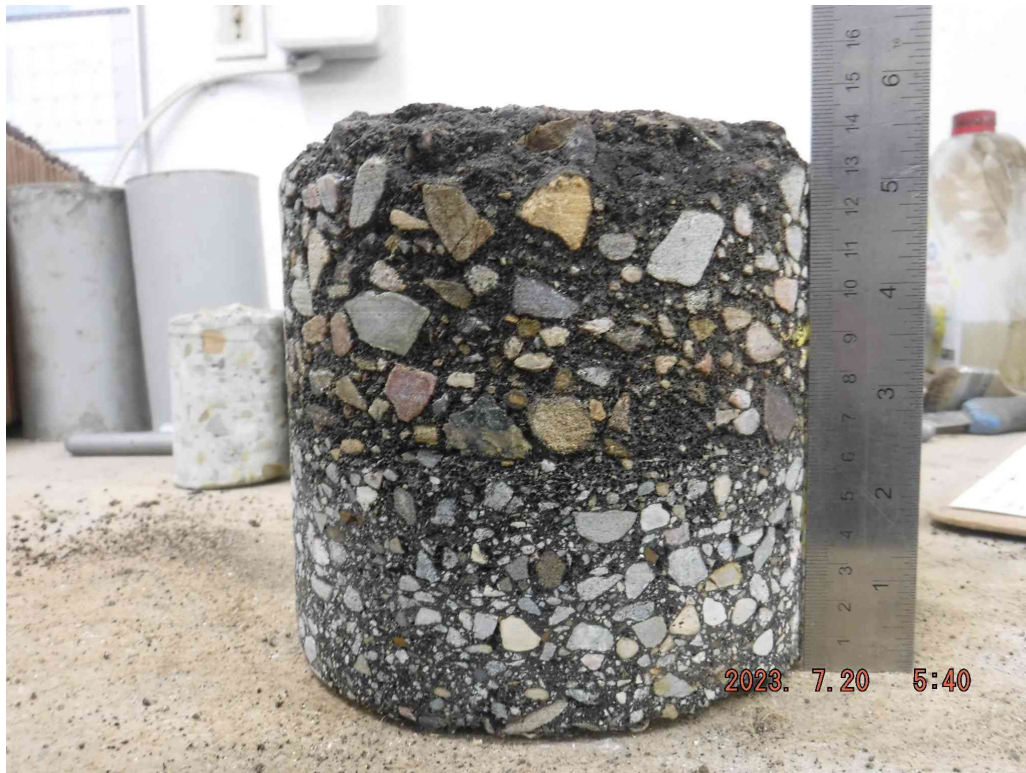
Photograph 1: Asphalt core from the location of BH23-2

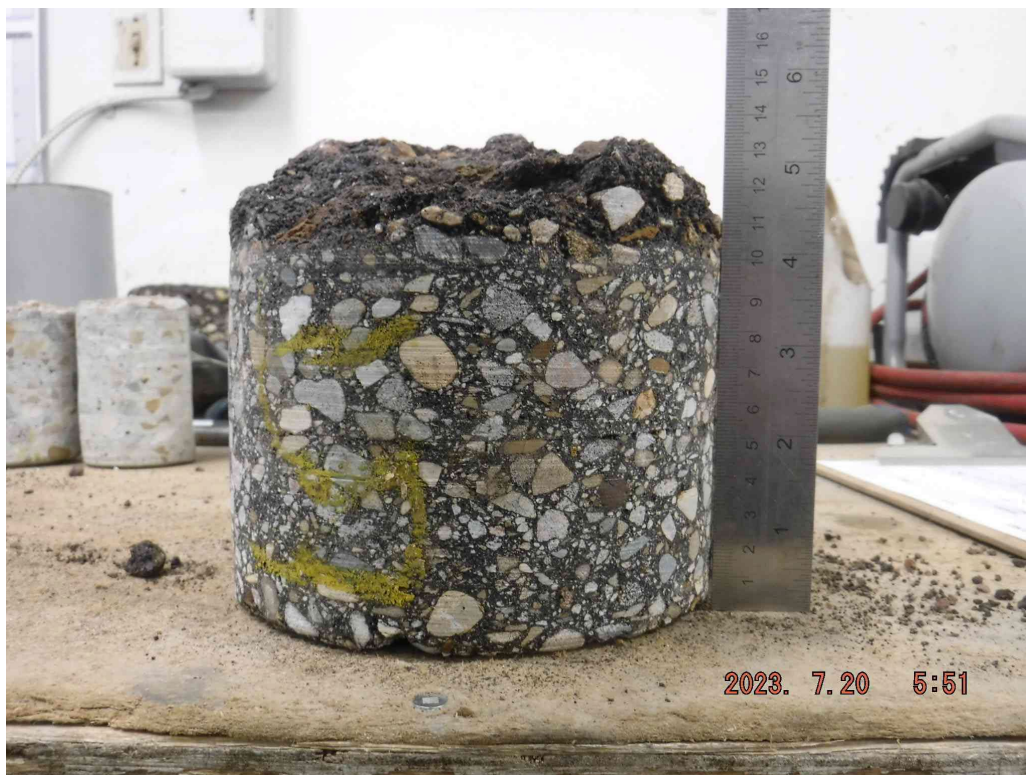
Photograph 1: Asphalt core from the location of BH23-5

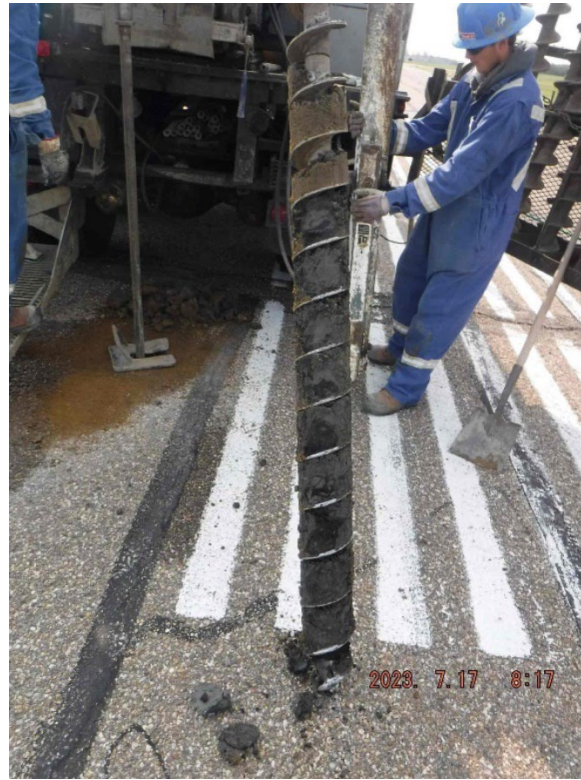
Photograph 3: Looking at auger retrieval (depths of 0.3 to 2.3 m at BH2-02)

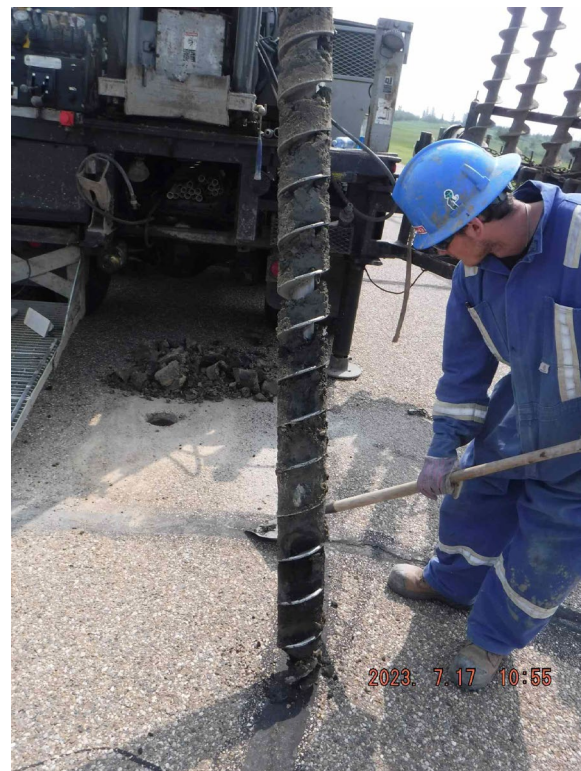
Photograph 4: Looking at auger retrieval (depths of 1.5 to 3.0 m at BH23-06)
